# AQUATIC PLANT MANAGEMENT PLAN FOR LITTLE CEDAR LAKE

## WASHINGTON COUNTY, WISCONSIN

COMMUNITY ASSISTANCE PLANNING REPORT  
NUMBER 146 (2ND EDITION)

May 2024

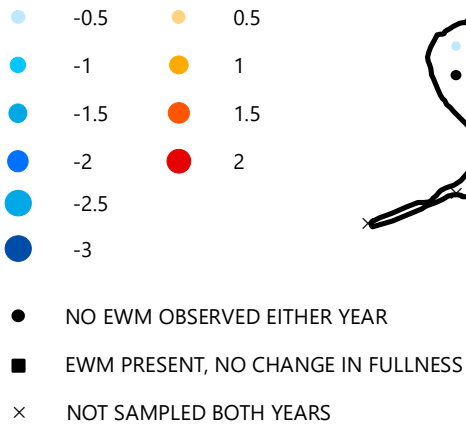
**Figure 2.7**  
**Change in Eurasian Watermilfoil (*Myriophyllum spicatum*)**  
**Distribution in Little Cedar Lake: 2018 vs. 2023**

**CHANGE IN EWM RAKE FULLNESS**

Note: Samples were collected in Little Cedar Lake between August 21 and 22, 2023.

EWM has substantially declined since the 2018 survey, when it was observed at 48.3 percent of vegetated points in Little Cedar Lake during 2018 compared to the 20.4 percent of vegetated points in 2023. The average rake fullness also declined from 1.47 in 2018 to 1.14 in 2023. This trend has continued a declining abundance of EWM in the Lake since 2000, when the littoral frequency of occurrence was 81.1 percent. The previous aquatic plant management plan attributed at least some of this decline to the effectiveness of chemical treatments targeting the EWM population.<sup>26</sup> The highest EWM coverage in 2023 was along the eastern and western shorelines of the northern basin (see Figure 2.7).
